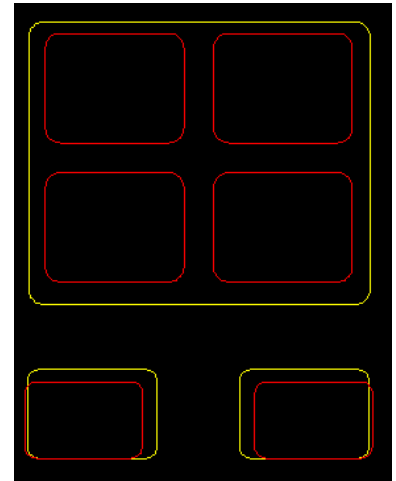
Customer was having various issues with LED device, their message was: **“The current stencil design as per manufacturer recommendation but still create a lot defects (Solder Bridge, Solder Balls, Component Tilt, Skew... etc.)”**

The 4 windows would help getting a uniform distribution of paste volume underneath the large pads, instead of centering solder in the middle using one brick, as that what might be causing the tilt & skew. With four bricks, solder would wet uniformly and not cause such defects.

For the terminal apertures, I recommend reducing the size of the apertures to reduce the volume of solder paste, and to move them apart to reduce the possibility of bridging, also to shift the apertures downward to help eliminating solder balls of being formed underneath the chip.

I recommended the design shown in the picture to the right (Red pads are stencil Apertures and Yellow ones are SMT Pads).

The stencil design is working fine.

There was 20% void on the LED's large aperture but meet the customer specification.

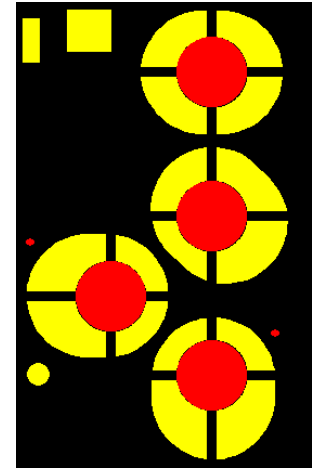
Customer stated that their product historically had insufficient solder fill on the pogo pins at some connector locations. Their old stencil was 5 mil and the aperture was cut 1:1. They wanted to redesign the bottom side stencil (where the pins are placed) to have 100% fill solder of the barrels and try to eliminate the touchup that was required for their assembly.

The other issue with this assembly is that the pins are too wide and pushing solder paste through the barrel to the other side of the PCB, for such application we may use a wagon wheel design to not print over the pins.

The image to the right shows the recommended stencil apertures (Yellow) aligned with the through hole pads (Red)

100% barrel fill is very hard to achieve as it would require very big apertures or too thick stencil, and considering the other components around the through hole components in this assembly the only option would be to use a step up stencil.

For PIP applications the stencil should print double the required solder paste volume as solder paste is 50% solder powered and 50% flux. To get 100% barrel fill, the stencil needs to be stepped up to 10mil thickness for the area where the connectors are, and to enlarge the apertures by 40% more than the old stencil aperture. Due to the very big apertures, the location of them needs to be shifted to maintain at least 15mil gap.

I'm please to share with you all that the recent stencil you designed and provided to us was a great success! I'm including a picture of the new stencil results, as you can see, the new stencil achieved what we had hoped for (complete barrel fill). There were no other issues reported with the other locations and the production team is quite happy that they no longer are required to touchup these assemblies. Great job and thank-you very much!
